RICHELIEU RIVER BASIN
CHITTENDEN, VERMONT

CHITTENDEN DAM

VT 00178

PHASE I INSPECTION REPORT NATIONAL DAM INSPECTION PROGRAM

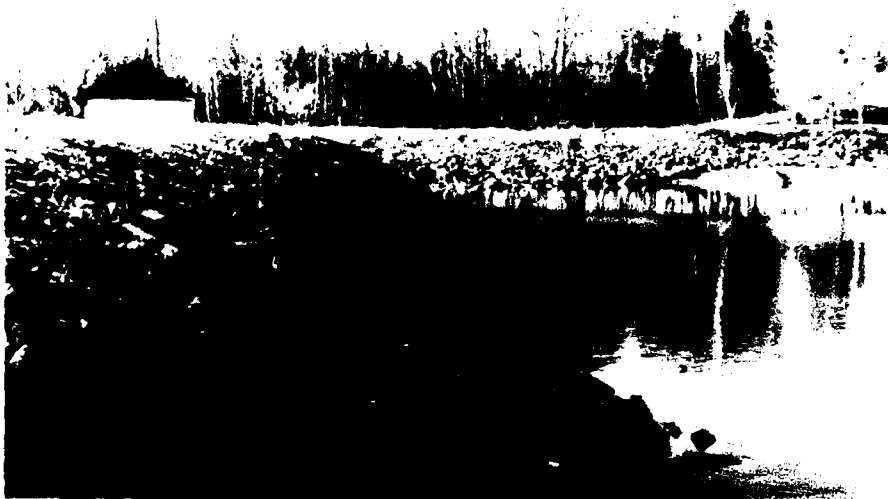
PHOTO NO. 7 - Upstream slope between spillway and right abutment.

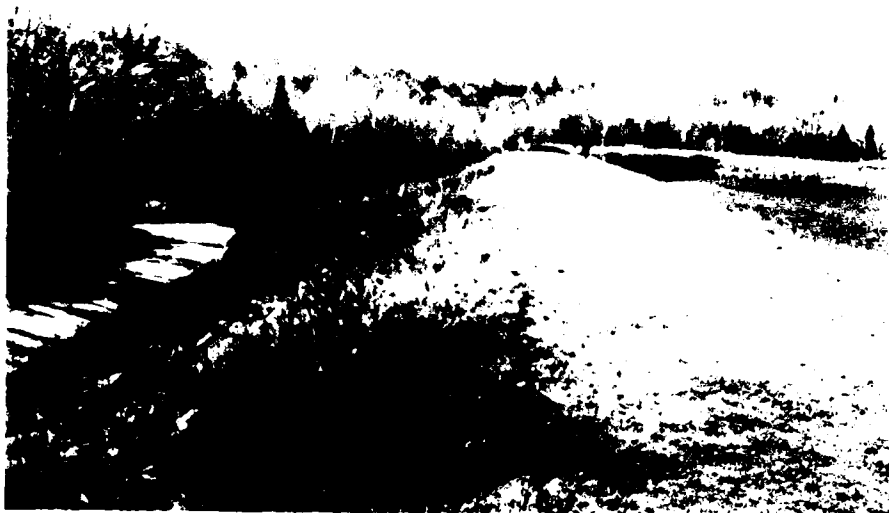
The crest of the dam has no pavement. Photo 5 shows a typical section of the crest which has an excellent grass cover. There was no evidence of cracking or misalignment due to significant embankment movements.

PHOTO NO. 5 - View of dam (downstream slope) from left abutment. Note excellent grass cover at crest of the dam.

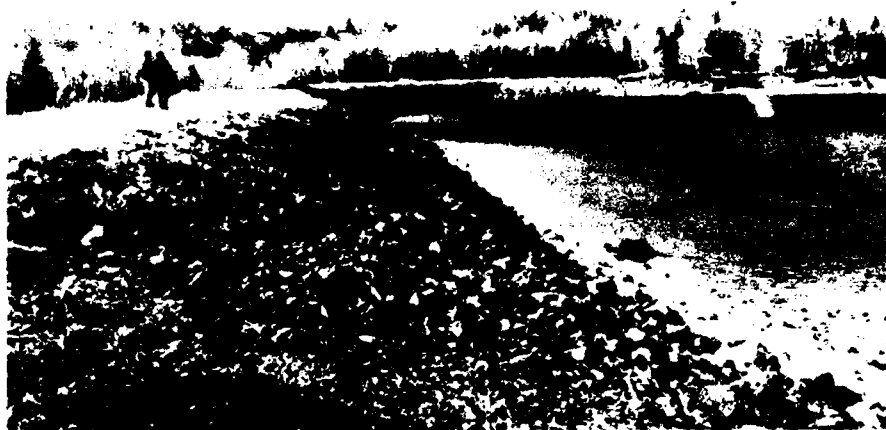
PHOTO NO. 3 - View of dam (upstream slope) from left abutment.

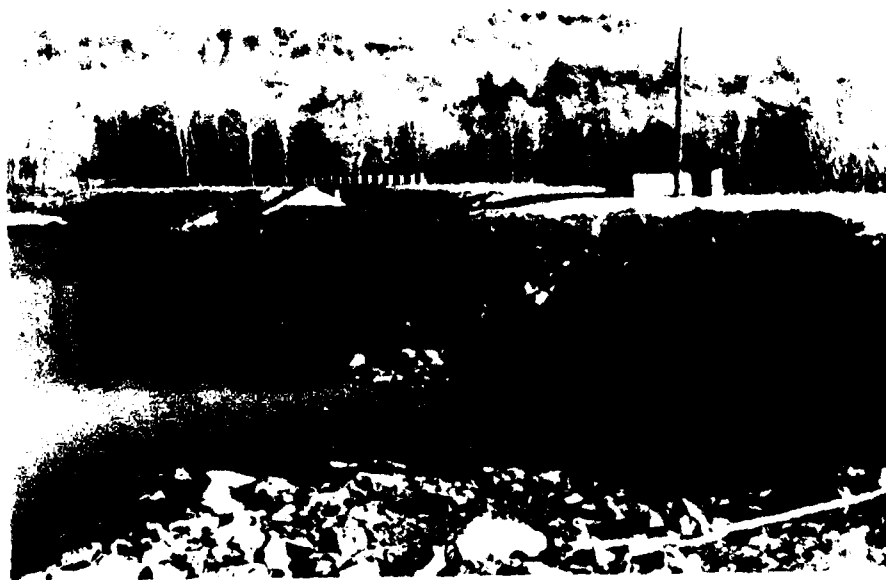
PHOTO NO. 4 - View of dam (upstream slope) from right abutment.

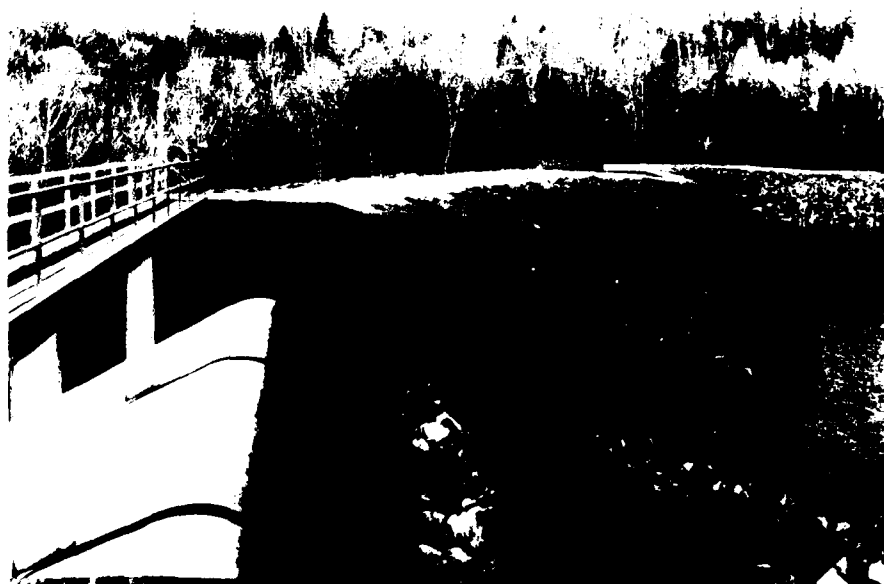
PHOTO NO. 11 - Spillway crest viewed from left training wall. No misalignment of concrete structures due to embankment movement.

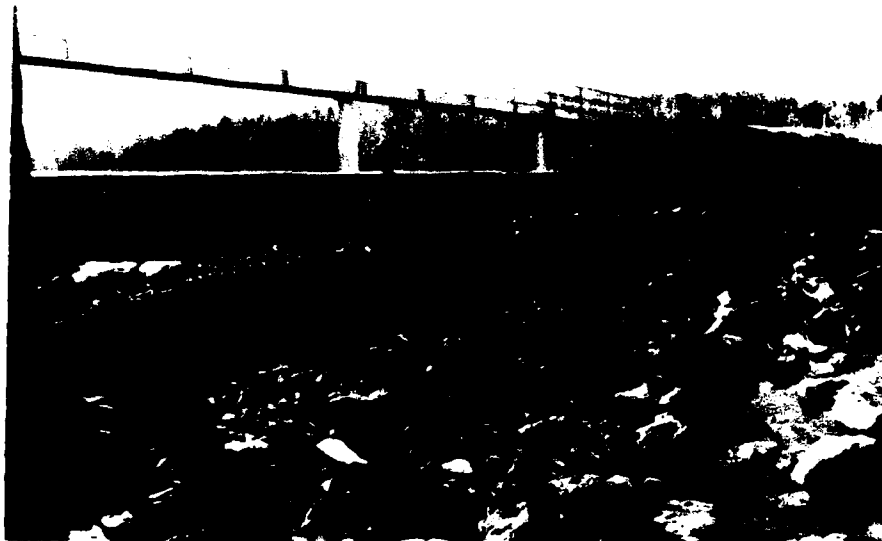
The spillway structure, shown in Photos 20 and 21, consists of two concrete retaining walls and concrete-lined spillway surface, shaped as shown on Section B-B, Figure 1 located in Appendix B. Field inspection of the training walls showed concrete surface cracks and rotational movement of some sections of these walls. These movements are about $\frac{1}{2}$ inch in the right training wall and 1-1 $\frac{1}{2}$ inches in the left training wall. (Relative movements between two lower sections of the training wall.)

The foot bridge over the spillway is a three span continuous beam structure (2-15" channel shapes). The main longitudinal beams, bearing plates, connections, railing and wooden floor are generally in good condition as shown in Photos 20, 21 and 22.

PHOTO NO. 20 - View of spillway and foot bridge from reservoir side.

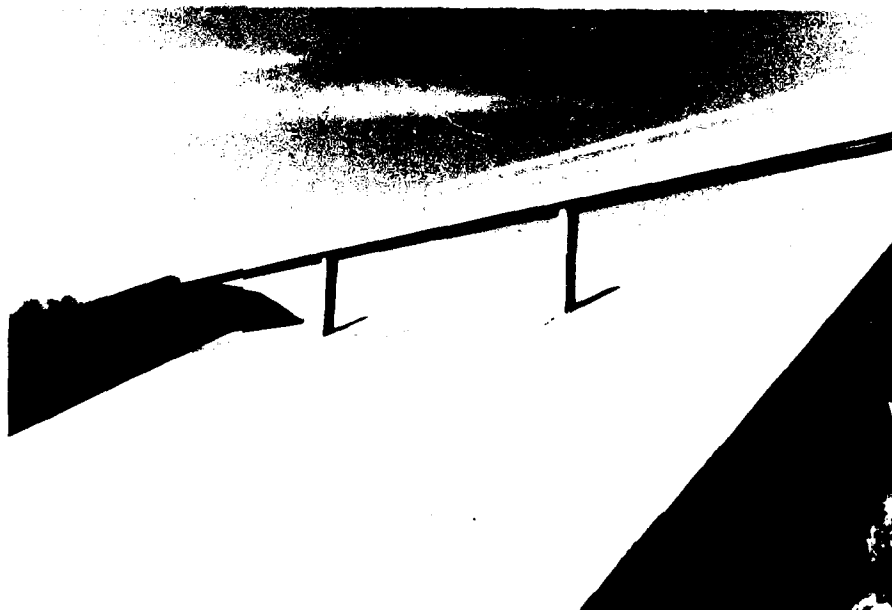
PHOTO NO. 21 - View of spillway and foot bridge structure from left training wall (downstream side).

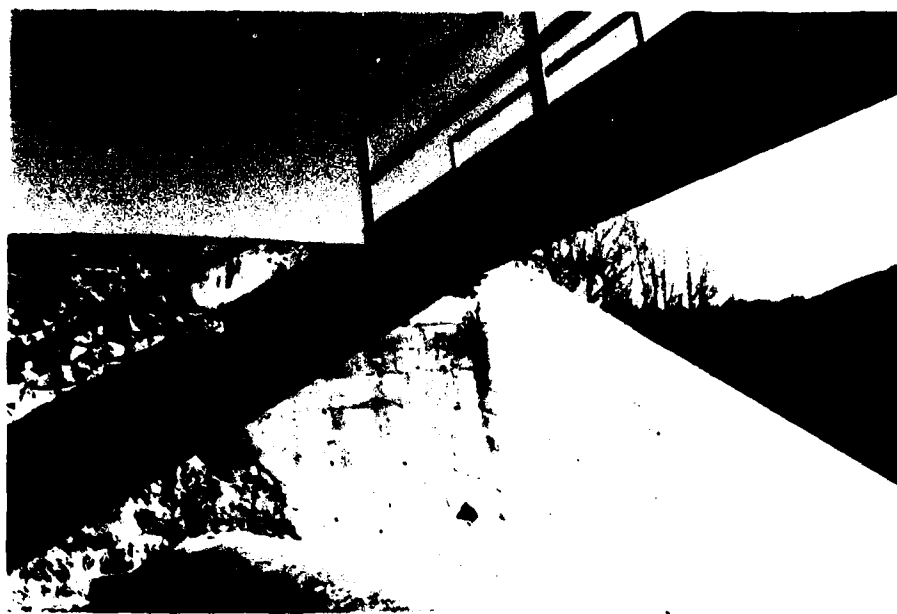
PHOTO NO. 22 - Left training wall at spillway crest with detail of foot bridge support.

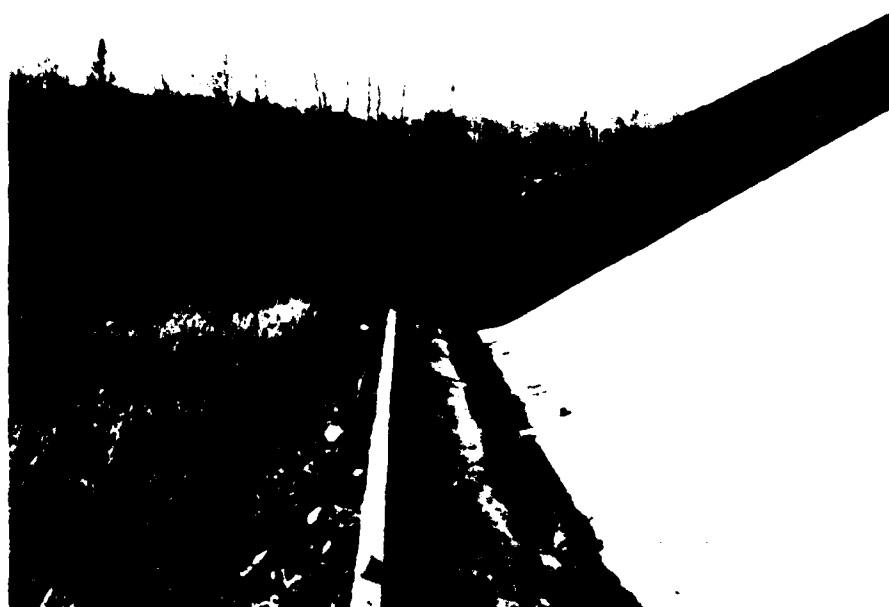
PHOTO NO. 23 - Spillway detail at discharge channel.

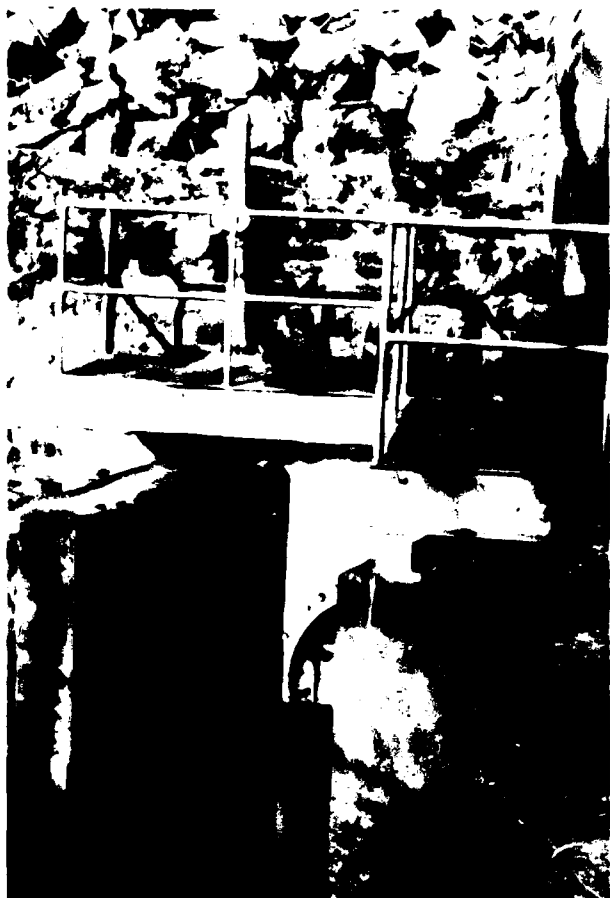
PHOTO NO. 26 - Detail of outlet
works structure at downstream
side of dam.
